**Houseboat Propeller Injury Avoidance Measures  
Proposed and Withdrawn by the U.S. Coast Guard:**

**An Analysis by the Propeller Guard Information Center**

**by Gary Polson P.E.**

**The Proposed Regulation Known as USCG 2001- 10163  
Proposed in December 2001 and Withdrawn in October 2007**

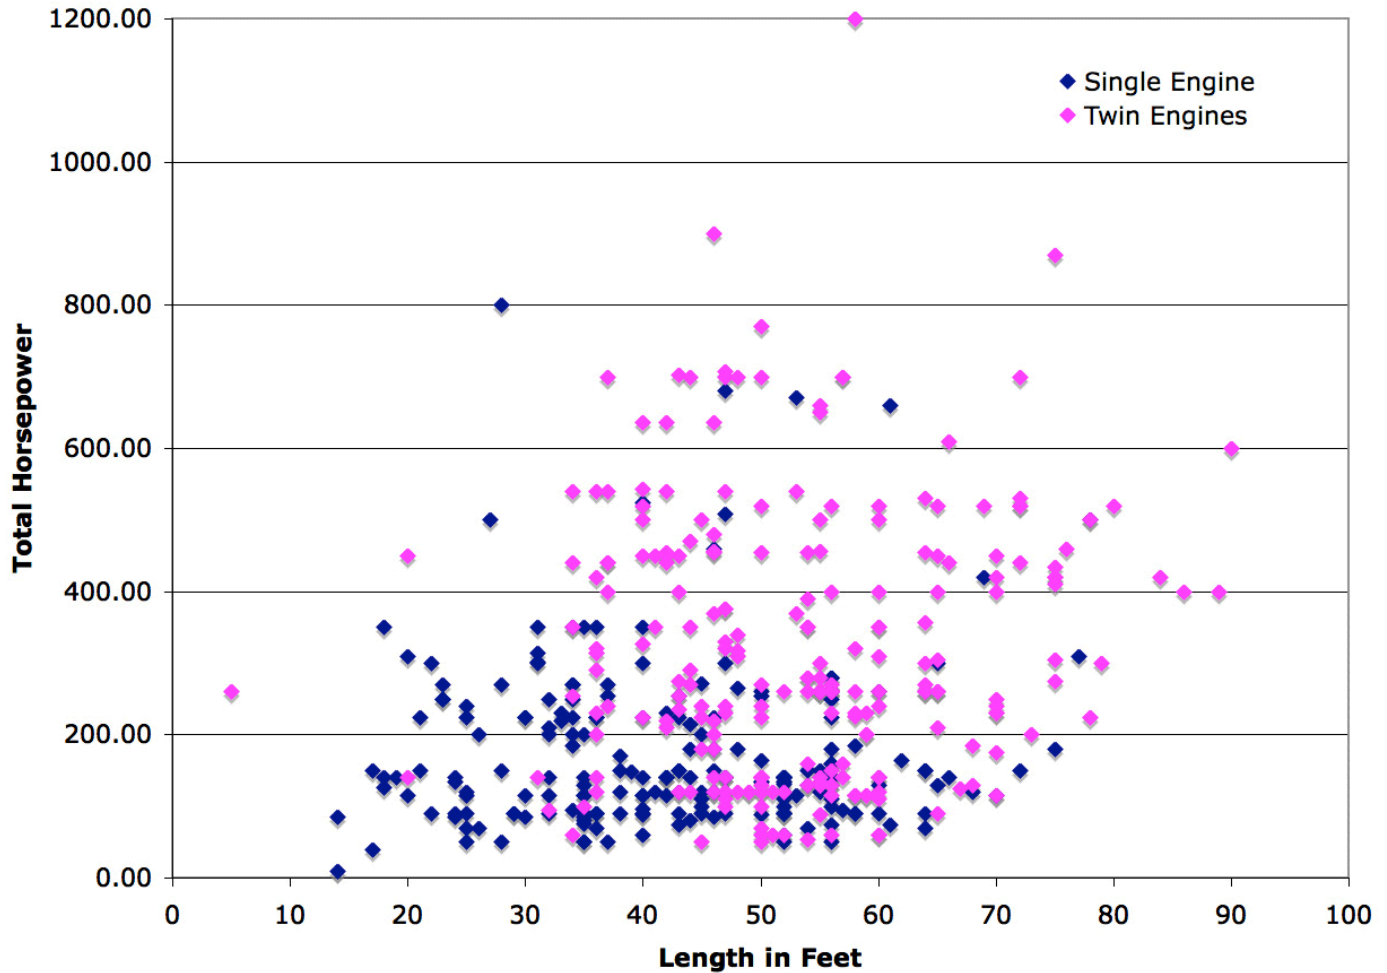
**Chart 1 Houseboat Total Horsepower by Length**

We plotted horsepower versus length for all houseboats in the 1995-2001 BARD databases, identified as being powered by single or twin engines for which length and horsepower data were provided, except one unit listed at 96 feet, 2900 horsepower. Results in Chart 1 show a large cluster of houseboats at or under about 150 horsepower almost regardless of length up to about 65 feet. Another group (the twin engine group) resembles a shotgun pattern centered at about 52 feet and 400 horsepower.

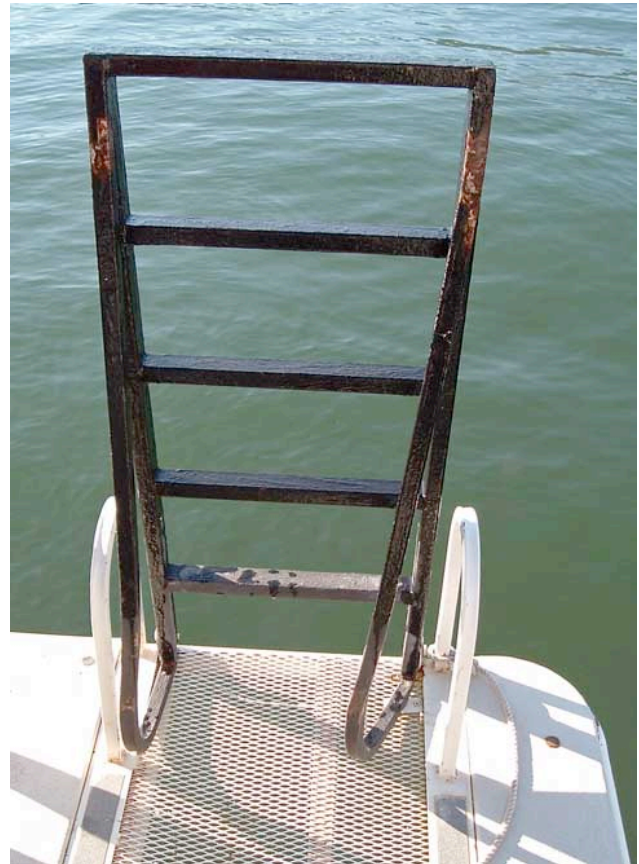
**Photograph 3. Fully Functioning Swim Ladder Interlock With Bent Ladder**

Swim ladder interlock switches are very durable, as seen in Photo 3 below. This houseboat swim ladder, with an interlock switch was hit by another boat, is noticeably bent (see bottom right of the photo), but the swim ladder interlock continues to function.

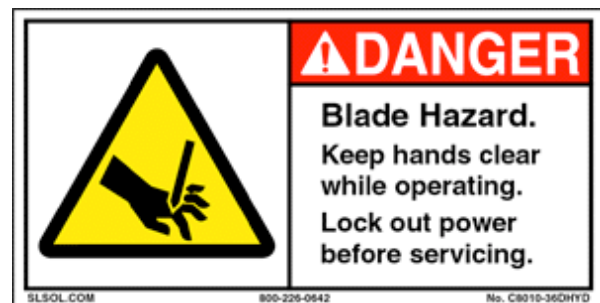
**Decal #3**  
**ANSI Z535 Warning Label Example**  
**Safety Label Solutions. Used by permission.**

As we understand it, BIRMC is currently (early 2010) still working on a propeller warning decal compatible with American National Standards Institute (ANSI) Z535 standards. A portion of the standard applies to warning labels placed on products. The standard describes a three part label using a signal word, (CAUTION, WARNING, DANGER), a pictograph to illustrate the hazard, and text describing how to avoid the hazard. Decal #3 from Safety Label Solutions is an example of an ANSI Z535 warning.
